ATTACHMENT TO L-1726

31 AUGUST 1966

CABLE BRIDGE UNDER CONSTRUCTION
TU DUNG, NORTH VIETNAM
1812N 10607E

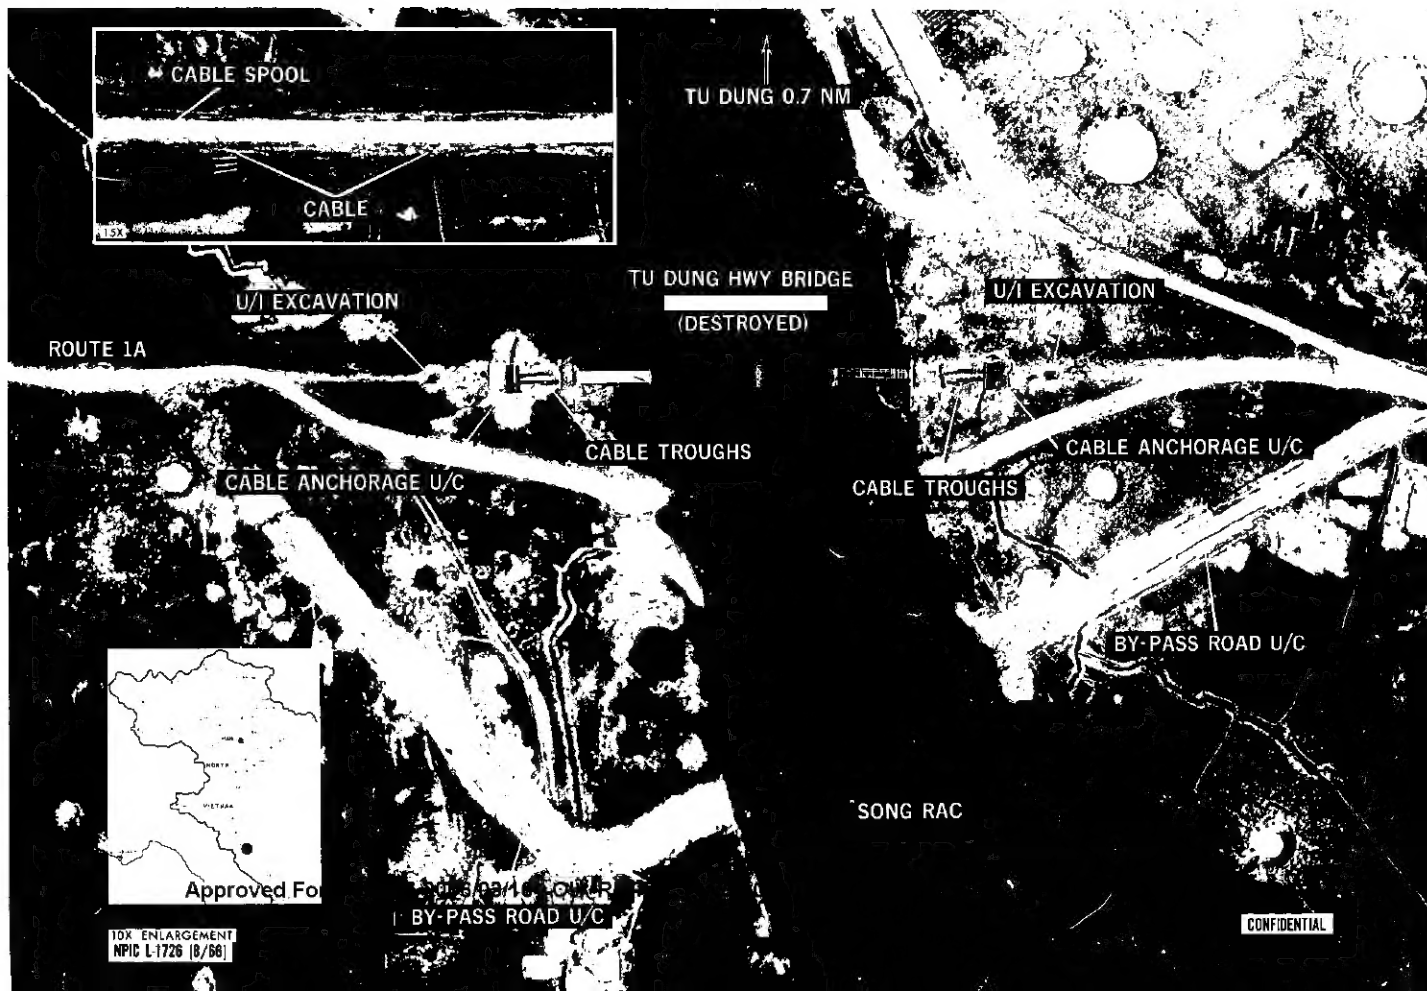
10X ENLARGEMENT
NPIC L-1726 (8/66)

THIS BRIEFING BOARD DEPICTS A CABLE BRIDGE IN MID-STAGES OF CONSTRUCTION NEAR TU DUNG, NORTH VIETNAM.

[REDACTED] REVEALS CONSTRUCTION TO CONSIST OF CABLE ANCHORAGES UNDER CONSTRUCTION ON BOTH BANKS OF THE SONG RAC (RIVER),

CABLE TROUGHS, AND UNIDENTIFIED EXCAVATIONS BEHIND EACH CABLE ANCHORAGE.
A SPOOL OF PARTIALLY UNROLLED CABLE LIES APPROXIMATELY 300 YARDS WEST
OF THE BRIDGE.

A BY-PASS ROAD IS OBSERVED UNDER CONSTRUCTION IMMEDIATELY NORTH OF
THE DESTROYED BRIDGE.
